ROOF CONDITION REPORT

FLAT & PITCHED ROOF AREAS

94-96 FAIRFIELD STREET

Date: March 2025

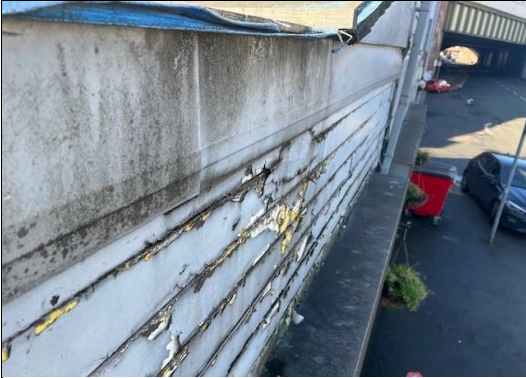
Photo 1
Location: North Elevation

Remarks: Rotten timber fascias due to lack of check kerb/parapet detail with rainwater falling onto face of building.
Condition/Priority rating: D1

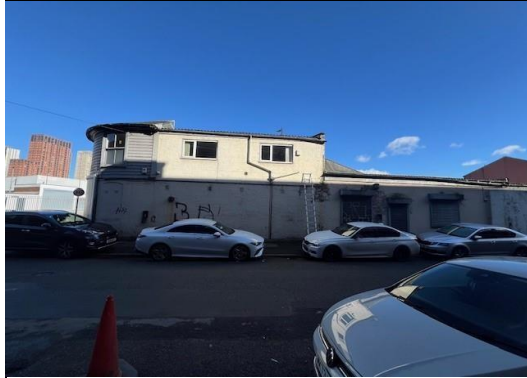
Photo 2
Location: West Elevation

Remarks: General overview of flat and pitched roof sections from North Western Street.
Condition/Priority rating: D1

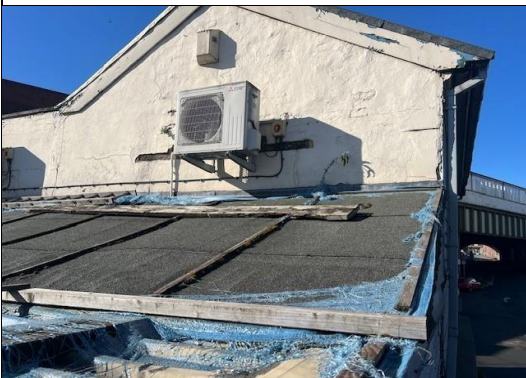
Photo 3
Location: Pitched roof (felt)

Remarks: Degraded membrane and rotten timbers to felt coverings.

Condition/Priority rating: D1

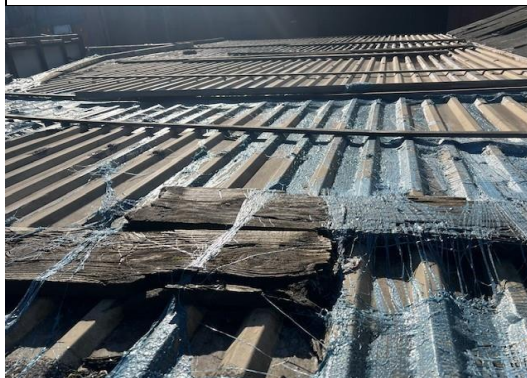
Photo 4
Location: Flat roof

Remarks: Rotten timbers to profiled metal coverings.

Condition/Priority rating: D1

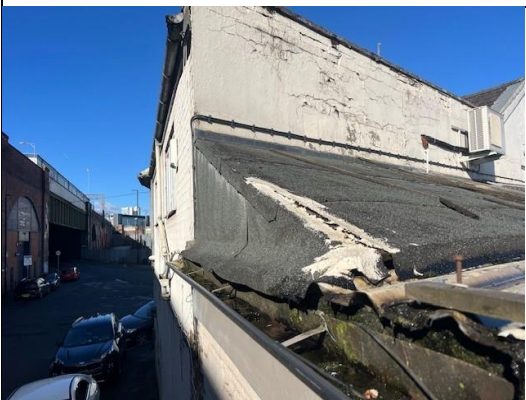
Photo 5
Location: Pitched roof (felt)

Remarks: Debonding of lap joints to felt coverings exposing structure.

Condition/Priority rating: D1

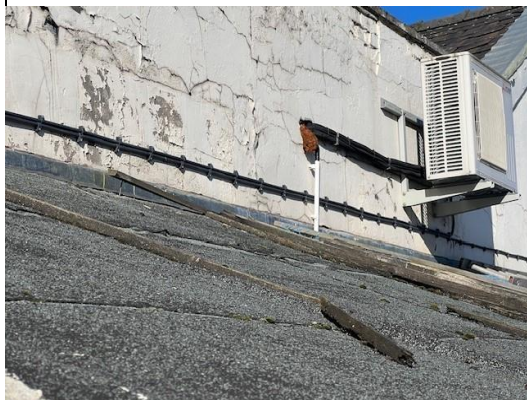
Photo 6
Location: Pitched roof (felt)

Remarks Upstand detail does not meet 150mm requirements.

Condition/Priority rating: D1

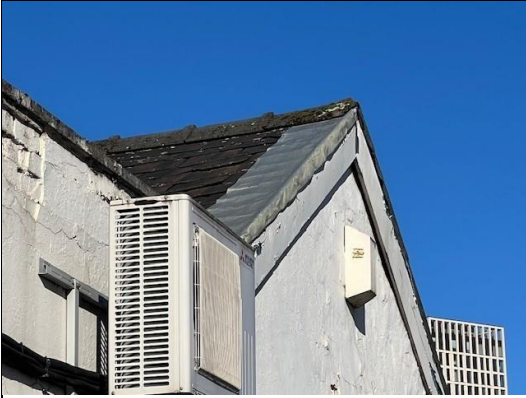
Photo 7
Location: Pitched roof

Remarks: Makeshift flashing repairs to gable end.

Condition/Priority rating: D1

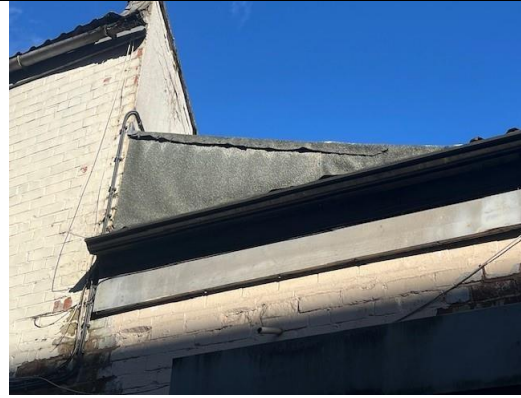
Photo 8
Location: Pitched roof (felt)

The mono-pitch felt roof coverings are blistered and debonding. Whilst isolated blisters in themselves can be repaired, in this instance blistering is so extensive its poor adhesion between the layers of felt and is indicative of poor installation and workmanship. This coupled with the other defects noted justify replacement.

Remarks: Blistering of felt coverings to abutment detail to mono pitch roof section.

Condition/Priority rating: D1

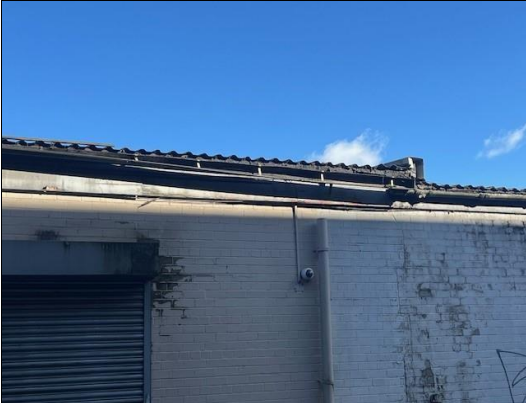
Photo 9
Location: Rainwater goods

Remarks: Section of gutter is loose due to defective fixings.

Condition/Priority rating: D1

- Provide new cast aluminium gutter and connections to downpipes to discharge water via external gutters and downpipes.
- Replacement of potential rotten roof timbers and structural restraints determined upon further intrusive investigations.

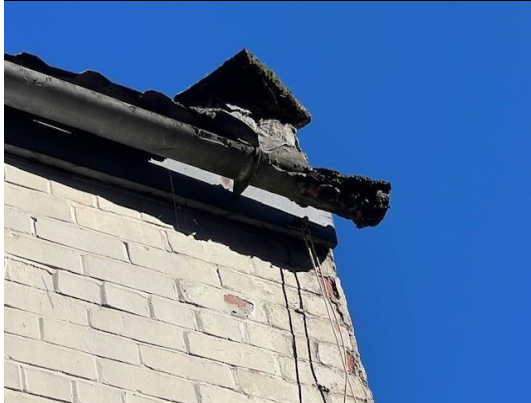
Photo 10
Location: Rainwater goods

Remarks: Deterioration of rainwater goods.

Condition/Priority rating: D1

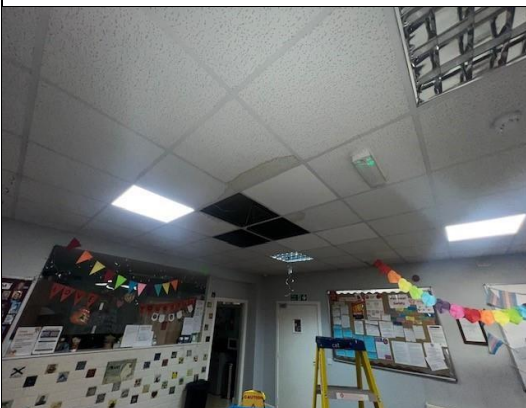
Photo 11
Location: Internals

Remarks: Failure of ceiling tiles due to water ingress.

Condition/Priority rating: D1

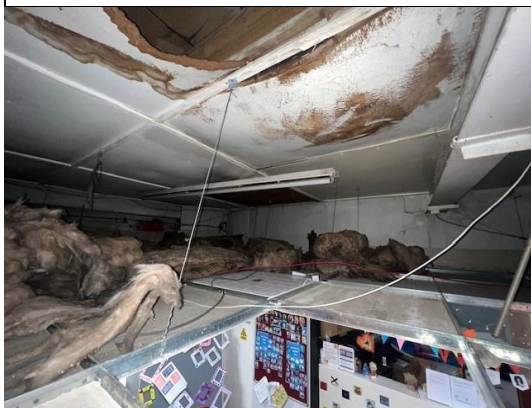
Photo 12
Location: Internals

Remarks: Secondary suspended ceiling with heavy damage due to water ingress.

Condition/Priority rating: D1

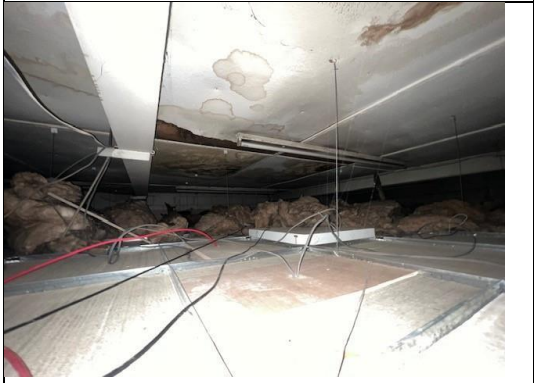
Photo 13
Location: Internals

Remarks: Secondary suspended ceiling with heavy damage due to water ingress.

Condition/Priority rating: D1

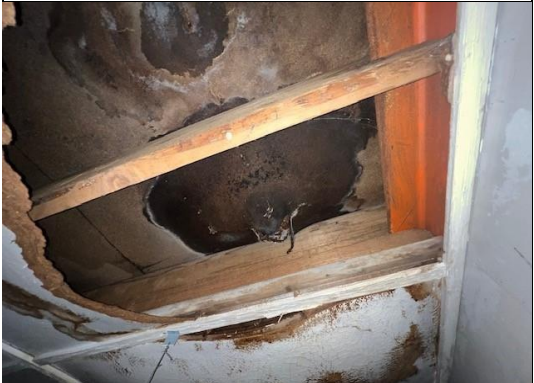
Photo 14
Location: Internals

There are no records of existing guarantees for the roof. The existing fiberboard deck is saturated, which has caused bulging of the deck and widespread leaks internally. The structural integrity of the fiberboard deck is of immediate concern due to the widespread leaks and general deterioration from persistent ingress.

Remarks: Underside of fibreboard deck which is saturated.

Condition/Priority rating: D1

- Internal plasterwork repairs as necessary
- Immediate investigation from a structural engineer to confirm the integrity of the existing fibreboard deck to the flat roof areas.

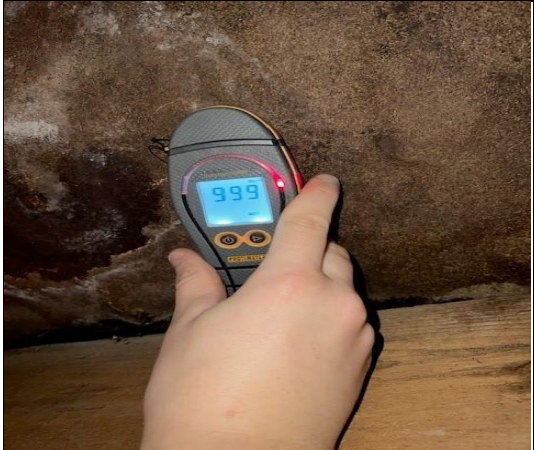
Photo 15
Location: Internals

Remarks: Damp reading to fibreboard deck.

Condition/Priority rating: D1

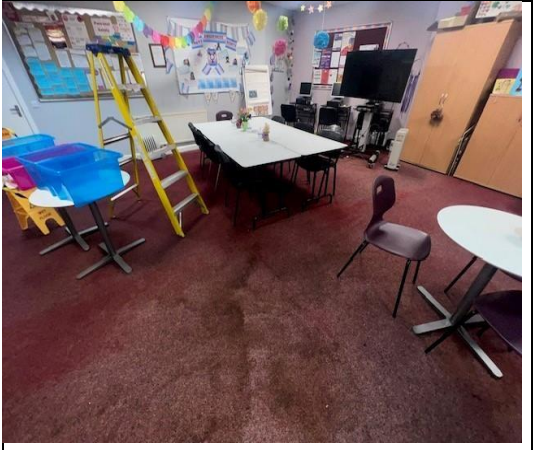
Photo 16
Location: Internals

Remarks: Historic staining to carpet finishes as a result of water ingress.

Condition/Priority rating: D1

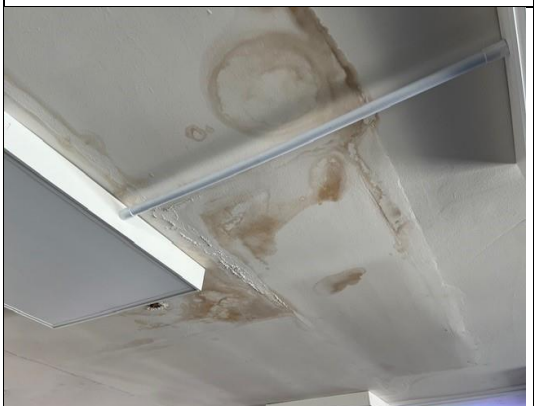
Photo 17
Location: Internals

Remarks: Historic ingress noted to plaster due to water ingress.

Condition/Priority rating: D1

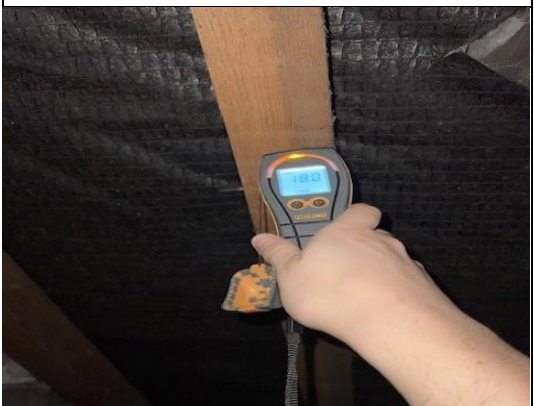
Photo 18
Location: Internals

The timber rafters to the pitch roof structure showing high readings of damp from members inspected. This will worsen over time if water ingress is persistent.

Remarks: Damp reading noted to pitched roof timbers at high risk of wet rot.

Condition/Priority rating: D1

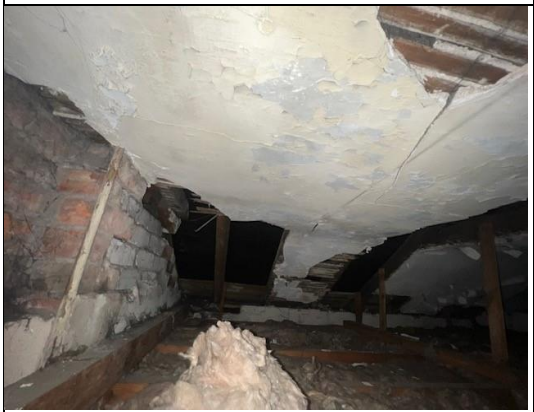
Photo 19
Location: Internals

Remarks: Historic lath and plaster ceiling finishes within pitched roof area failing as result of ingress.

Condition/Priority rating: D1

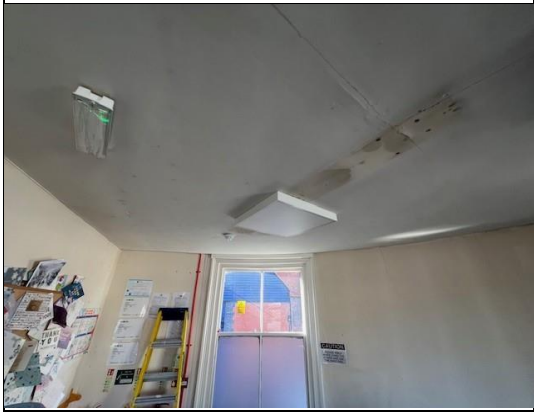
Photo 21
Location: Internals

Remarks: Removal of defective light fittings due to water ingress.

Condition/Priority rating: D1

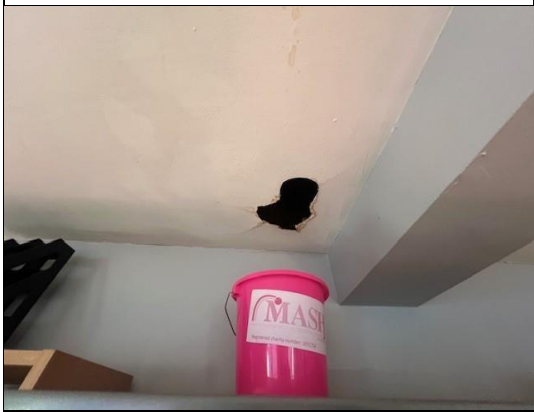
Photo 23
Location: Internals

Remarks: Damage to plastered ceiling finishes due to water ingress.

Condition/Priority rating: D1
